Technical Workshop C3P & NASA 2007

Hexavalent Chrome Removal in Aircraft Painting Schemes

Joana Vide Pereira - C3P

November 9, 2007

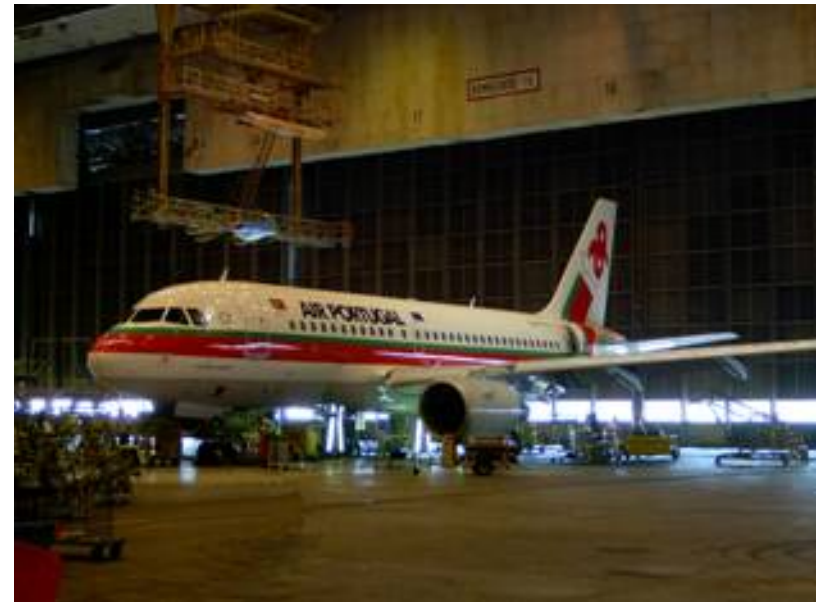
Aircraft Tests

- TAP painted one service door of an A319 Aircraft;
- The following systems were applied:

➤ The follow-up reports of the Aircraft door show that both painting systems are in perfect conditions:

- No peeling-off;
- No defects were observed;
- Present high gloss and DOI
(Distinctness of Image)

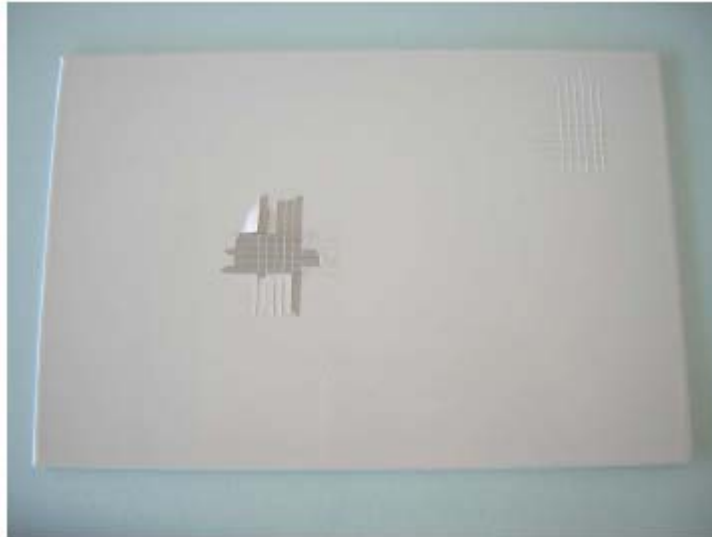
M Coupons

Classification “5” - All the squares have detached wholly

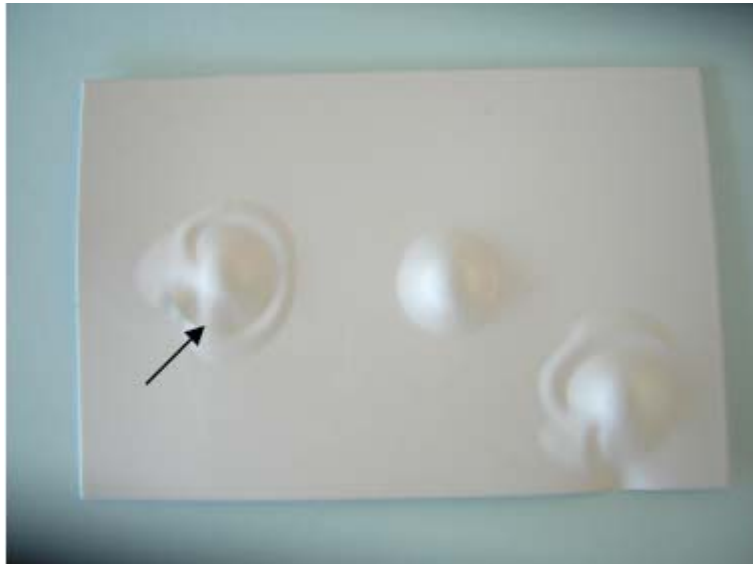
M Coupons

Coating has loss of adhesion in all impacts and as cracked in 1

The substrate has not cracked

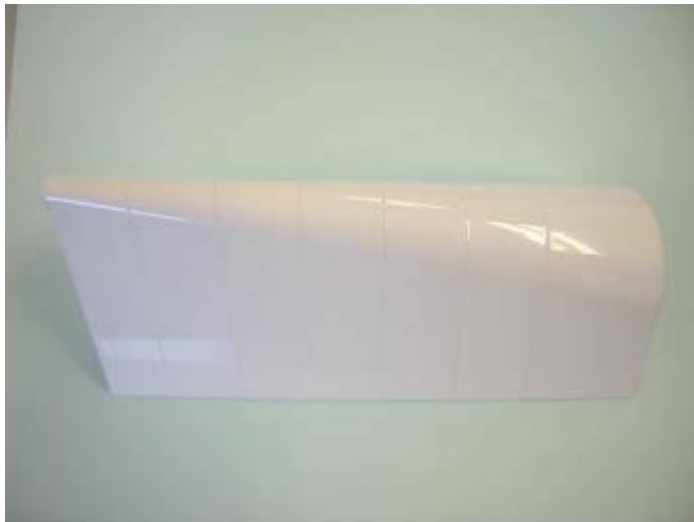
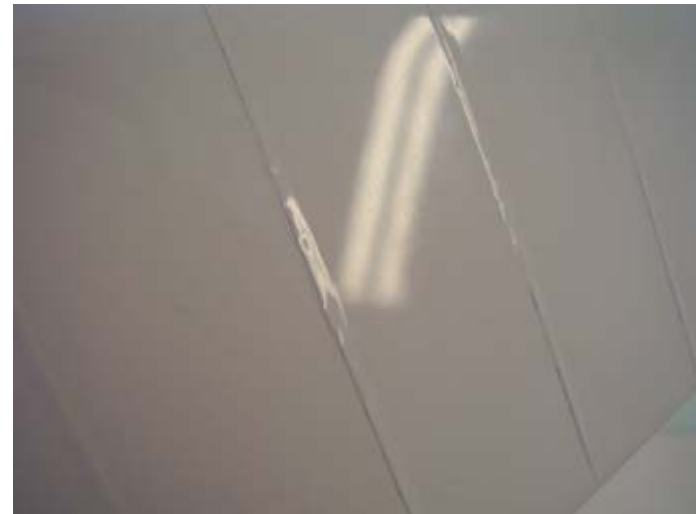
There is no cracking – some peeling was noted at the edges of the incisions after bending

There is no peel, no damage, no cracking

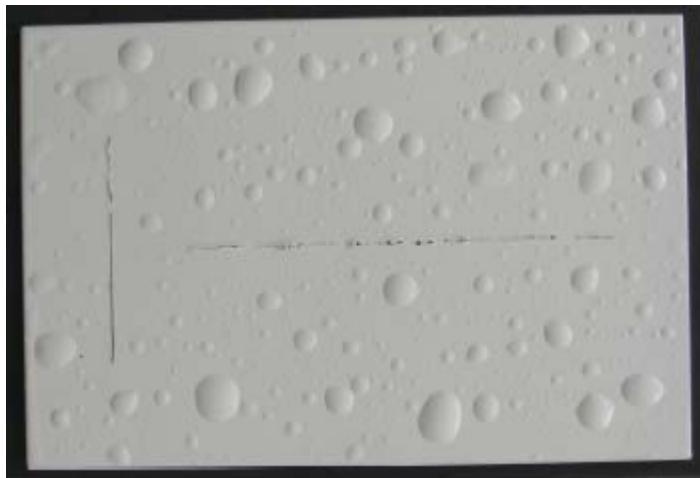
M Coupons

Test Conditions: 1h of HCl exposure; humidity chamber with 40 ± 2 °C of temperature and 82 ± 3 % of relative humidity for 1000h

No evidence of filiform corrosion → Some blistering in the M coatings

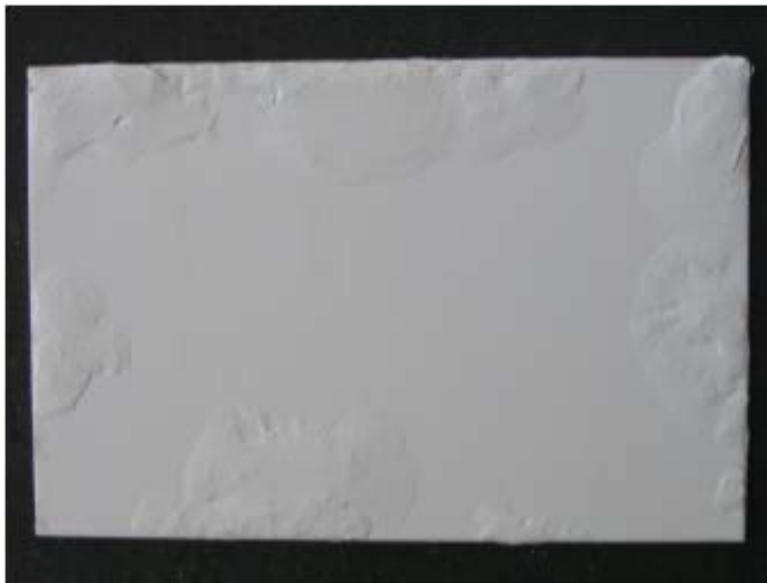
Conditioning: 3000 hours at 35°C; 50g/L NaCl Solution; pH 6.5-7.2.

- Evidence of corrosion was present in all the coatings.

**M Restored Coupons
after 3000 hours**

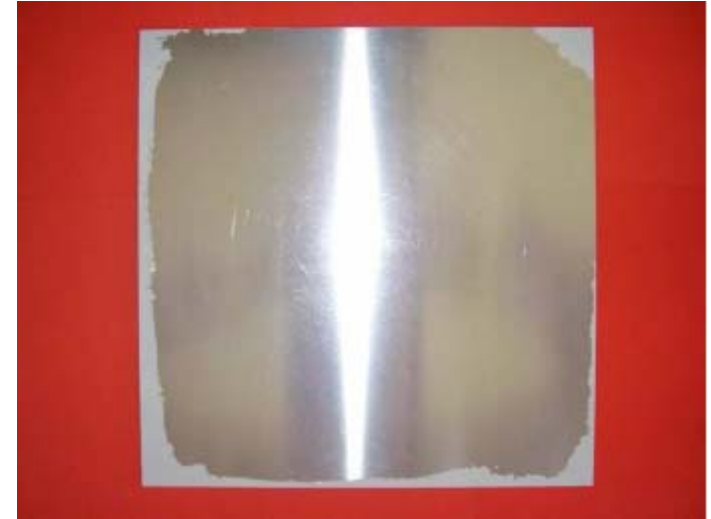
All coupons have passed the test (minimum requisite for the test was 95% removal in 7 hours); although, the P coatings took much longer to remove the paint than the M coatings.

M Coupon after scrubbing.
